Osteolysis with Total Hip Prosthesis

By Patrícia Leitão MD, António J. Madureira MD, Rui Cunha, MD
 Department of Radiology, Centro Hospitalar de São João, Porto, Portugal

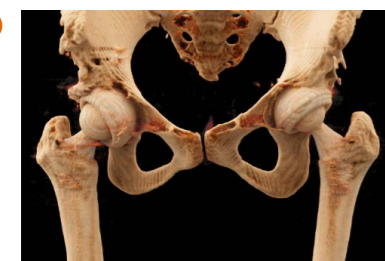
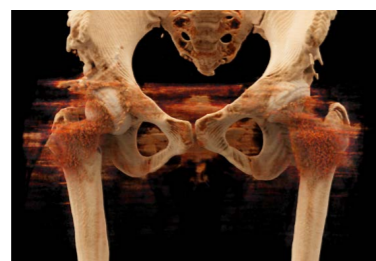
1 – 3 Coronal MPR (Fig. 1, soft window setting and Fig. 2, extended bone window setting) and cinematic VRT (Fig. 3) images show that the components of both prostheses are correctly positioned, with no signs of fracture or displacement. Severe metal artifacts caused by bilateral prostheses (B) are significantly reduced when using iMAR (A).

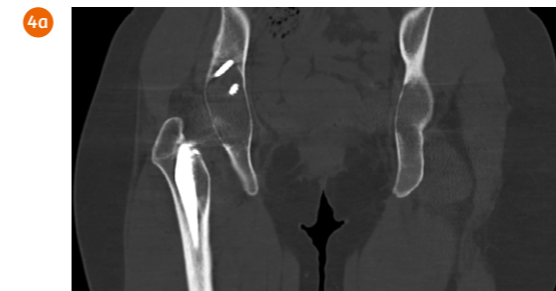
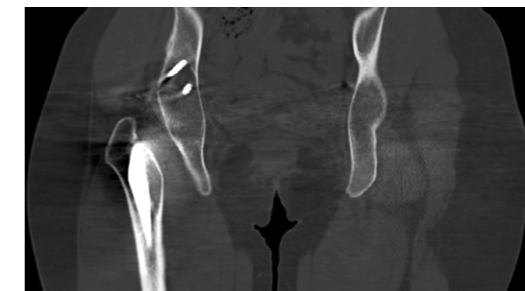
CT images depicted the prosthetic components to be correctly positioned without signs of fracture or dislocation. Nevertheless, low-attenuation areas between the uncemented acetabular cup and the bone suggested osteolysis and loosening.

4 A 3-mm coronal MPR image using iMAR (Fig. 4a) shows loss of bone trabeculation in the right acetabulum, suggesting osteolytic changes related to particle disease. The metal artifacts caused by the prosthesis in the image without iMAR (Fig. 4b) impair the image quality and evaluation.
 5 A VRT image shows the dense structures (bone and metallic prostheses) of the hip. Note how the peri-prosthesis lucencies adjacent to the right acetabular cup are well depicted in this three dimensional presentation.

Given the image findings and taking into consideration patient complaints, an arthroplasty revision was per-

formed. This confirmed prosthesis failure with loosening and a small loculation of fluid. An anatomo-pathological evaluation of submitted peri-prosthetic tissue revealed metallosis and foreign body reaction thus histologically confirming particle disease.
