Case 5

Evaluation of Femoral Artery Pseudoaneurysms with Arteriovenous Fistula using CTA Runoff Scanning

By Hong Liang Zhao, MD

Department of Radiology, Xijing Hospital, Xian, P.R. China

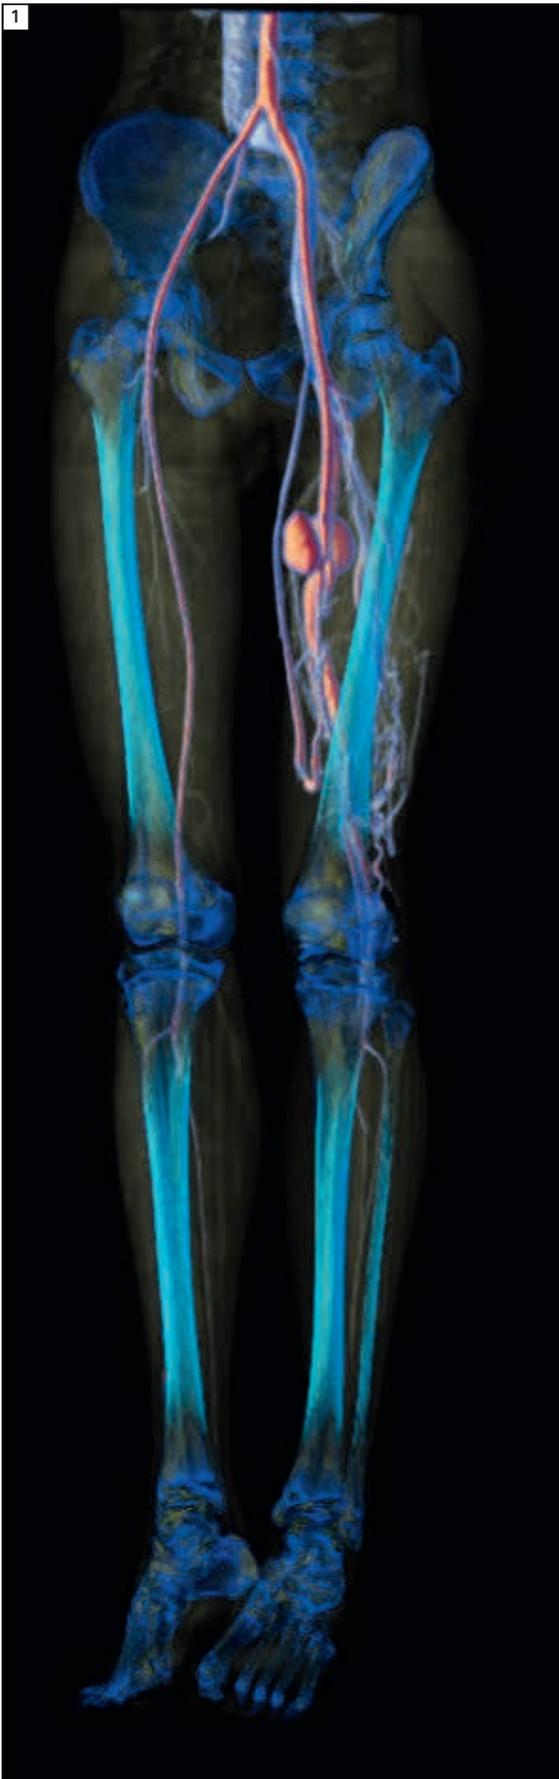
1 An overview of the CTA runoff.

Two saccular pseudoaneurysms were found in the left upper-mid thigh (Fig. 1). Both aneurysms breached into the left superficial femoral artery (Fig. 2). Tumor-like venous structures developed locally, due to a fistula connecting the aneurysms and the femoral vein (Fig. 2). Most of the veins drained into the great saphenous vein, resulting in an ectatic state of the vein. The left femoral artery was significantly dilated. There were neither signs of mural thrombosis nor of wall thickening of the aneurysm. The vascular structures in the right leg appeared to be normal.

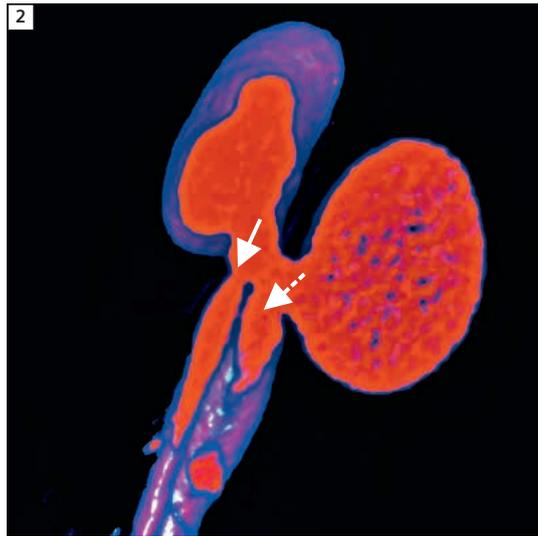
2 Thin slab VRT image shows the breach of the aneurysm (arrow) and the fistula to the femoral vein (dashed arrow).

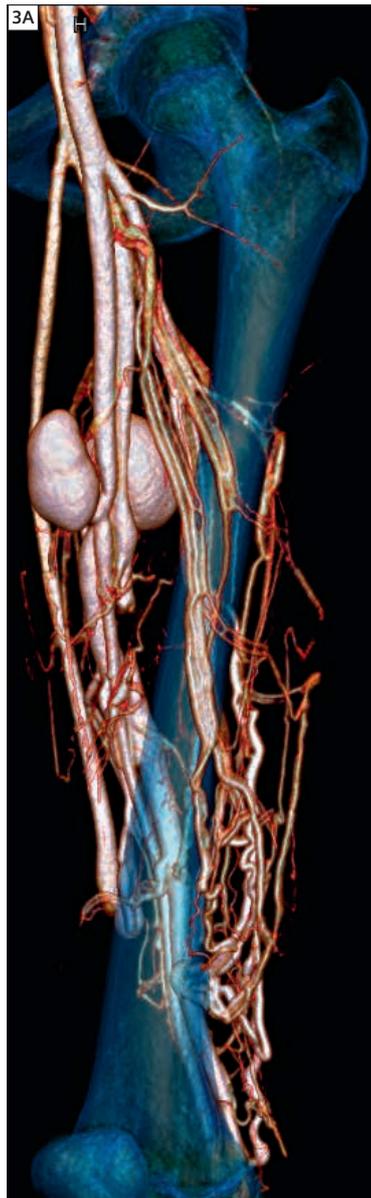
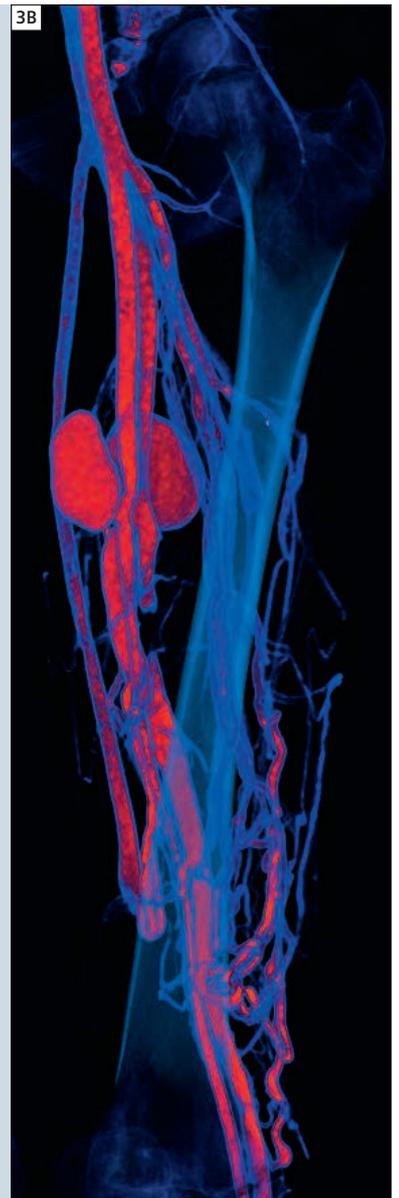
3 The vascular structures can be shown with VRT images using different presets.
